**DRINKING WATER QUALITY REGULATOR
FOR SCOTLAND**

Drinking Water Quality in Scotland 2018 Public Water Supply

SAFEGUARDING YOUR DRINKING WATER QUALITY

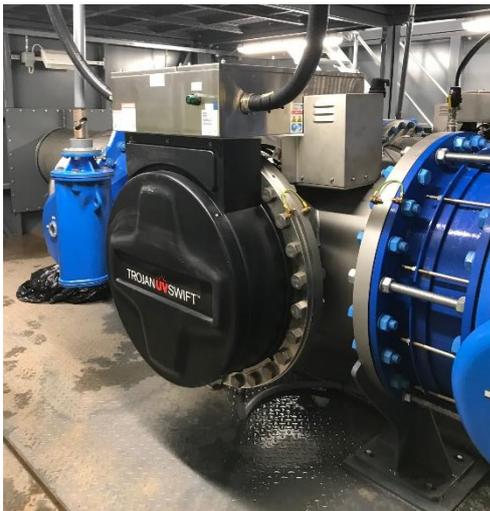
UV filter, Turriff WTW

Turriff WTW in Aberdeenshire had four *Cryptosporidium* detections in 2018 which were attributed to poor filter condition and performance. Scottish Water installed UV treatment in November 2018 to inactivate *Cryptosporidium*. Bonnycraig WTW, which serves Peebles in the Scottish Borders, recorded two *Cryptosporidium* detections, again, due to inadequacies in filter performance, and UV was installed in April 2017. In April 2019, DWQR served Scottish Water with enforcement notices for both Turriff WTW and Bonnycraig WTW due to ongoing *Cryptosporidium* detections in the supplies. These enforcement notices contain requirements for the short term, including optimisation of

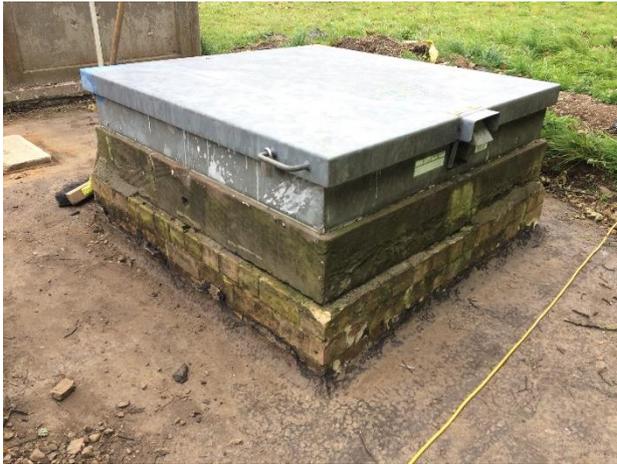
A sample taken from the outlet of Lawton service reservoir failed for eight coliforms on 15th June. A resample on 16th June failed with three coliforms and a further sample on 18th June also failed with 610 coliforms. Due to the repeat nature and levels of the failures, the tank was bypassed on 19th June and drained for inspection on 22nd June. There was one failure of samples taken at consumers' taps in the area over the period of reservoir failures. The reservoir remained bypassed whilst repair works are carried out and subsequent sampling and routine monitoring carried out showed water quality to be satisfactory. Investigation of the condition of the service reservoir identified a number of issues with the structural integrity which permitted routes of ingress of surface water into the storage space from which contamination could occur. This was categorised as a 'Significant' water quality event. DWQR was satisfied from the reports provided and our visit that these defects were the likely cause of the sample failures.

Lawton SR hatch, before repairs

Scottish Water took the necessary actions to respond to this event, isolating the service reservoir and taking samples to verify there were no continuing issues for consumers. DWQR was however of the view that the incident could have been avoided. An investigation in response to similar microbiological failures in September 2016 identified actions to remove the tank from service for cleaning and investigation but this had not been carried out due to risks at the time to the security of supply from other utility works being carried out in close proximity to

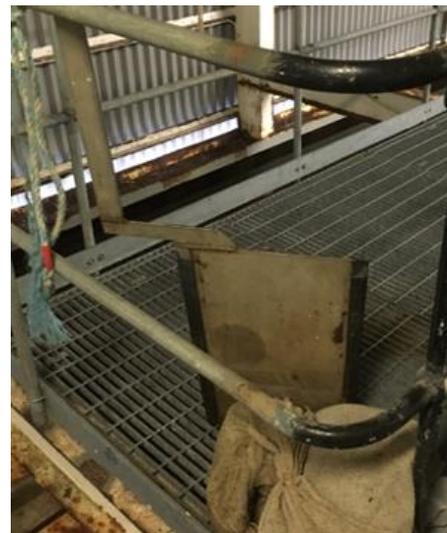
On 7th November, the polyelectrolyte batching at the site failed due to insufficient capacity in a temporary service water pipe. The alarm which would have alerted staff had also been wrongly assigned a low priority so was not passed to standby staff by the Control Centre. Once water quality had deteriorated, a filtered water aluminium alarm alerted staff and the polyelectrolyte dosing was quickly reinstated. Aluminium levels in the filtered water were above the PCV for four hours, peaking at 454 µg/l. This issue was not escalated correctly within Scottish Water to enable appropriate sampling to take place.

The following day, planned work commenced to clean one of the two flatbed clarifiers (FBCs) at the site. The approach used to return the FBC to service after cleaning was to introduce it at a very low flow to enable a floc blanket to form. However, flow through the plant was higher than the last time the FBC was cleaned and the other clarifier was no longer able to take the full works output. Additionally, the very rudimentary flow control at the site meant that it was not possible to properly restrict (or measure) the flow through the reintroduced clarifier. Consequently the level of water stored in the clear water tank was dropping throughout the operation, adding pressure on staff to complete the process as quickly as possible. Shortly after re-introduction of the FBC, aluminium concentrations and turbidities began to rise, reaching in excess of 300 µg/l. Concentrations did not return to normal for approximately six days.

Rudimentary penstock - the only means of controlling flows to clarifiers at Eela WTW
